Manhole Inspection Summary

Manhole # S07EE1011MH

Location Address: **OAKFORD AVE** Cross Street: **AYRDALE AVE**

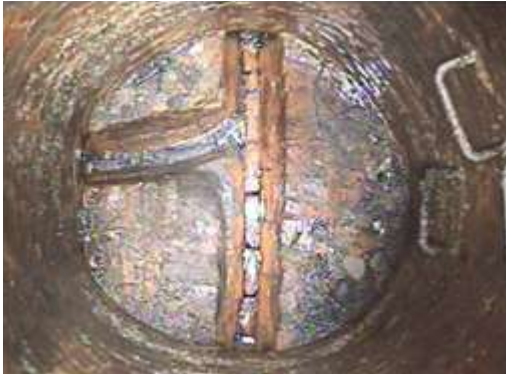
Defect 1

Steps Count: **5** Missing: **0** ☒ **Corroded**

Surcharge ☒ **Evidence Of Surcharge** Depth: **2** (ft.) ☐ Active Surcharge Present

evidence of surcharge and corroded step

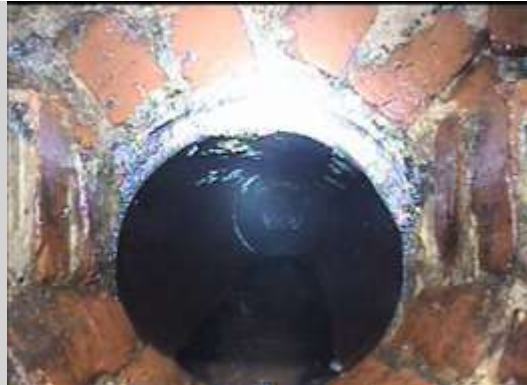
12 O'Clock Outflow

8 in. Circular Gravity Sewer
Pipe Out @ 12 O'Clock

Pipe Height: (in.) Direct
Pipe Material: **Clay** ☐ Pipe Lined
Invert Depth: **9.48** (ft.) Flow Characteristics: **Slow**
Deposits: ☒ None ☐ Mud ☐ Sludge ☐ **Debris** ☐ Grease
Silt Depth: (in.) Deposits Extent:
Infiltration: **None** Pipe Seal Cond: **Sound**

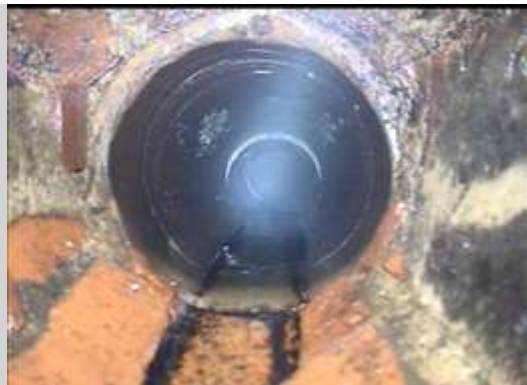
6 O'Clock Inflow

8 in. Circular Gravity Sewer
Pipe In @ 6 O'Clock

Pipe Height: (in.) Direct
Pipe Material: **Clay** ☐ Pipe Lined
Invert Depth: **9.34** (ft.) Flow Characteristics: **Slow**
Deposits: ☒ None ☐ Mud ☐ Sludge ☐ **Debris** ☐ Grease
Silt Depth: (in.) Deposits Extent:
Infiltration: **None** Pipe Seal Cond: **Sound**

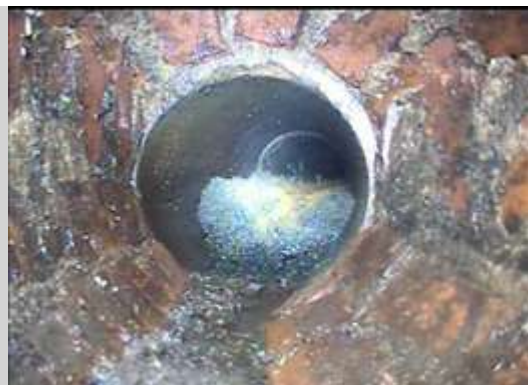
9 O'Clock Inflow

8 in. Circular Gravity Sewer
Pipe In @ 9 O'Clock

Deposits: ☐ None ☐ Mud ☐ Sludge ☒ **Debris** ☐ Grease

Silt Depth: **3.5** (in.) Deposits Extent: **Medium**
